TECHNICAL REPORT GL-85-11

DUSTPROOFING UNSURFACED AREAS; FACILITIES TECHNOLOGY APPLICATION TEST DEMONSTRATIONS, FY 84

Geotechnical Laboratory

September 1985

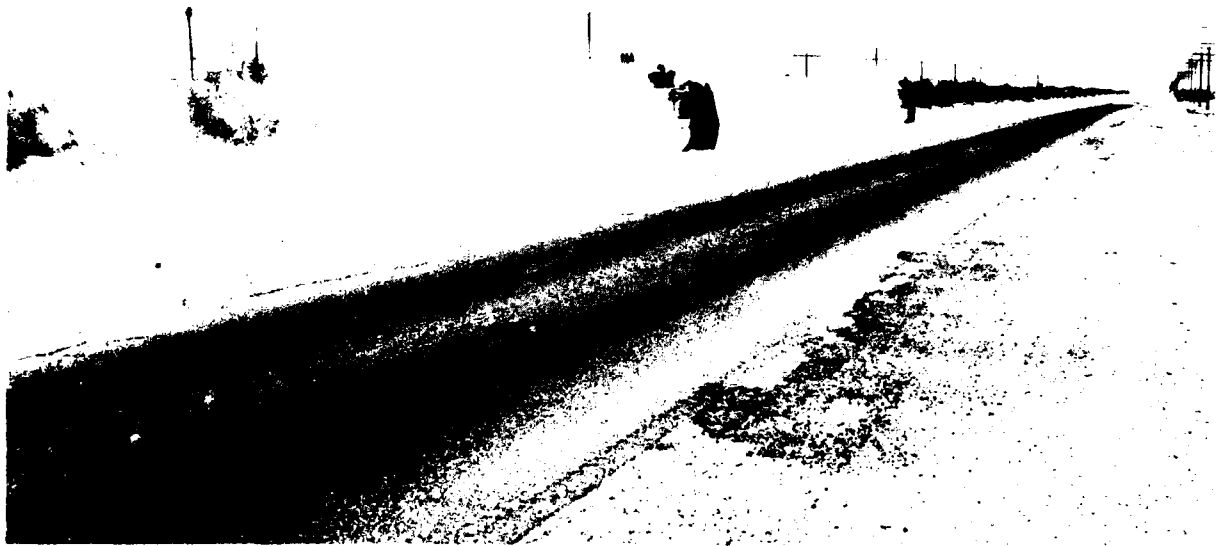
8. Fort Stewart, Ga., and Fort Bliss, Tex., were selected for the fiscal year 1984 demonstration sites. Both locations had an immediate need for dust control. Wheeled and tracked vehicles were producing dust on the silty sand roads, and this dust was blowing into the family housing area (Fort Stewart) and nearby adjacent commercial enterprises (Fort Bliss, Figure 1).

Figure 1. Dust at Fort Bliss, Tex., prior to treatment

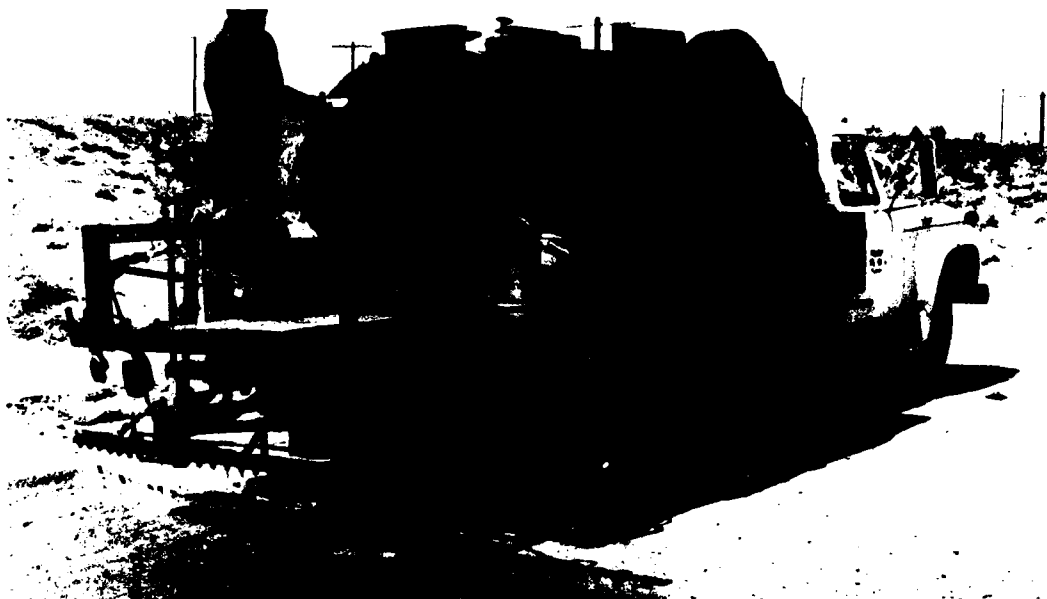
a. Applying product MgCl_2 to tank trail

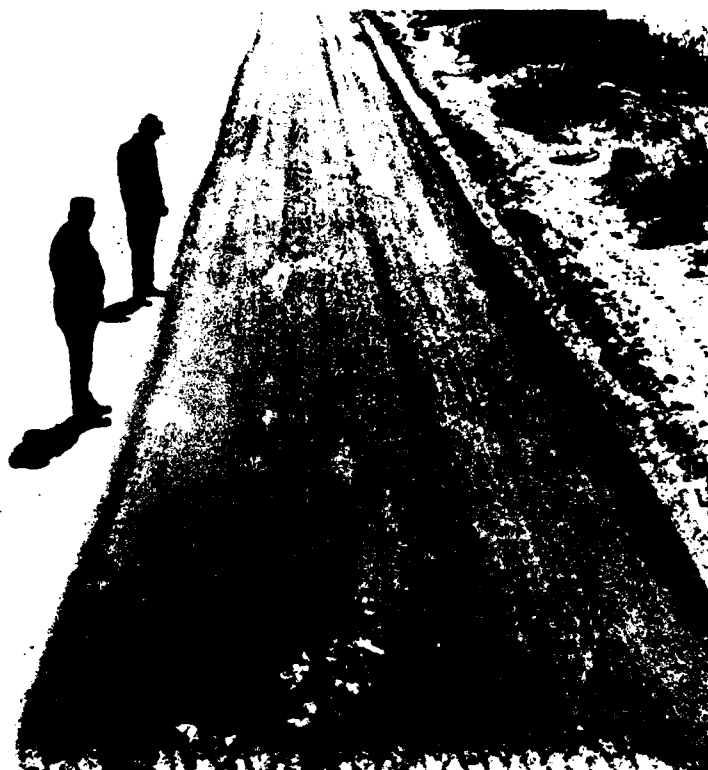
31. The application rate for the $MgCl_2$ was set in the same manner as described for the PVA. The actual application rate realized was very close to the desired rate, 0.5 gal/sq yd (Figure 11a). Product $MgCl_2$ requires no cure period and the treated areas can support traffic immediately (Figure 11b).

b. The MgCl_2 treated surface, Fort Bliss, Tex.
